**DEPARTMENT OF TRANSPORTATION**

Contract #: 04-0120F4Cty: SF/ALA Rte: 80 PM: 13.2/13.9File #: 1.28**WELDING INSPECTION REPORT****Resident Engineer:** Casey, William**Address:** 333 Burma Road**City:** Oakland, CA 94607**Report No:** WIR-029936**Date Inspected:** 23-Aug-2013**Project Name:** SAS Superstructure**OSM Arrival Time:** 700**Prime Contractor:** American Bridge/Fluor Enterprises, a JV**OSM Departure Time:** 1730**Contractor:** American Bridge/Fluor Enterprises, a JV**Location:** Job Site**CWI Name:** Bernie Docena**CWI Present:** Yes No**Inspected CWI report:** Yes No N/A**Rod Oven in Use:** Yes No N/A**Electrode to specification:** Yes No N/A**Weld Procedures Followed:** Yes No N/A**Qualified Welders:** Yes No N/A**Verified Joint Fit-up:** Yes No N/A**Approved Drawings:** Yes No N/A**Approved WPS:** Yes No N/A**Delayed / Cancelled:** Yes No N/A**Bridge No:** 34-0006**Component:** SAS Tower ,OBG**Summary of Items Observed:**

## WELDING INSPECTION REPORT

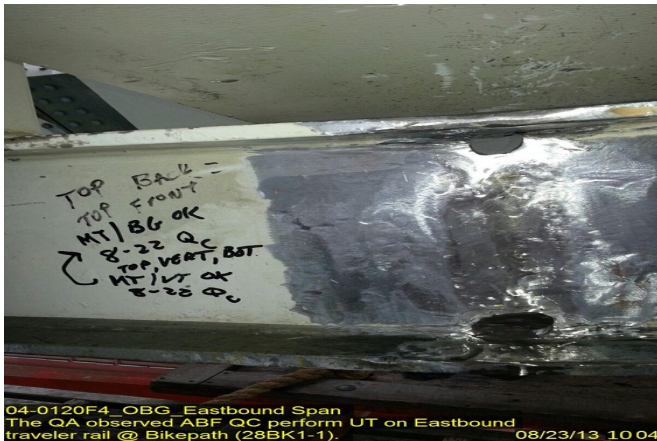
Eastbound Maintenance Traveler Rail (28BK1-1) @ Bikepath

The QA Inspector observed ABF QC Inspector Bernie Docena perform 100% Ultrasonic Testing (UT) on Eastbound Maintenance Traveler Rail (28BK1-1) complete joint penetration splice. Mr. Docena stated that the work is being performed per ABF (RFI) Request For Information -003407R00. The QC Inspector also stated that the inspection is being performed per AWS D1.5-Table 6.3. The UT inspection was performed on approx. 526mm of top flange, bottom flange & web splice on the Traveler rail. The QA also performed UT of the above mentioned weld location in accordance with the applicable code requirements. Mr. Docena provided the QA Inspector with a courtesy copy of the NDT report. See TL-6027 for additional details on the items inspected on this date.
